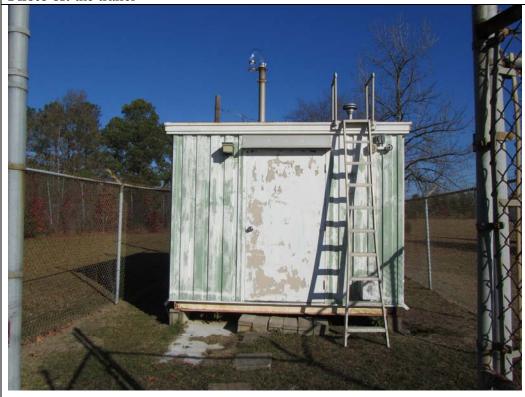
**Photo of:** the trailer

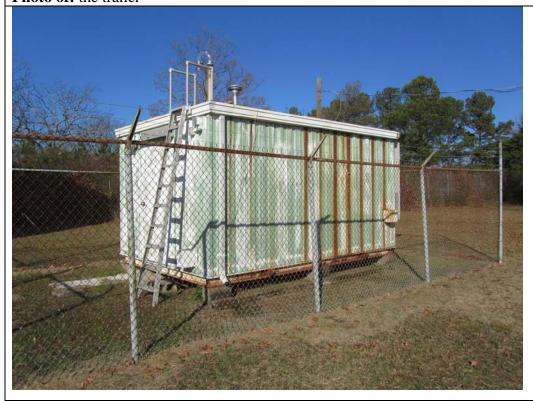
**Photo of:** the trailer

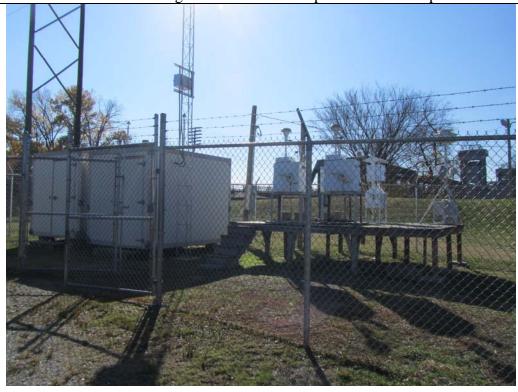
**Photo of:** the site including two trailers and the platform with the particulate matter (PM) samplers

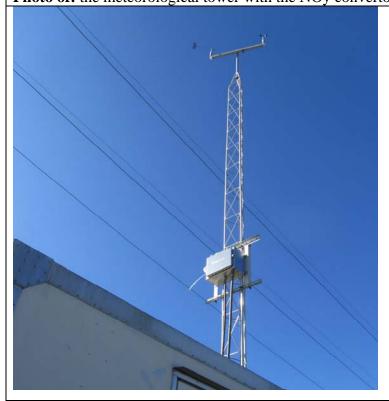
Photo of: the meteorological tower with the NOy convertor box attached

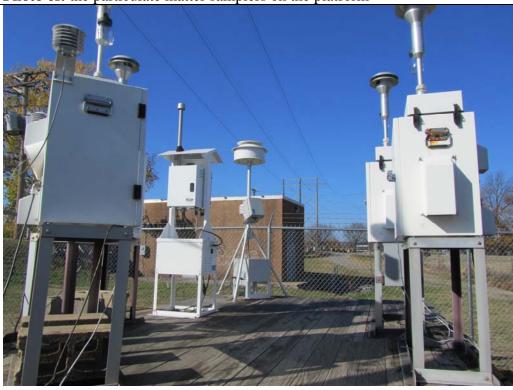
**Photo of:** the particulate matter samplers on the platform

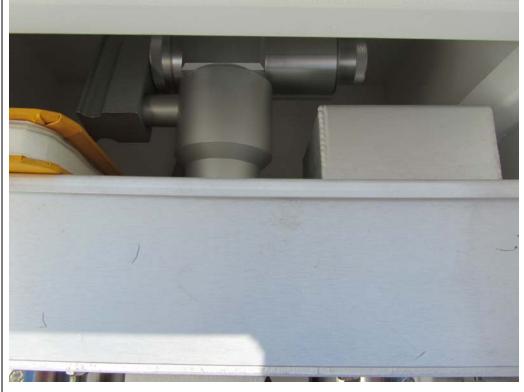
**Location:** PARR site (AQS #05-119-0007) **Photo of:** inside a PM2.5 sampler

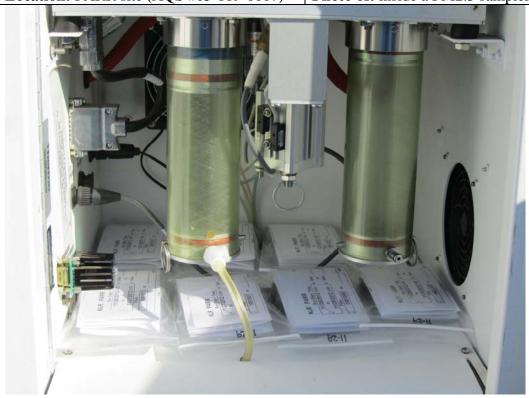
**Location:** PARR site (AQS #05-119-0007) **Photo of:** inside a PM2.5 sampler

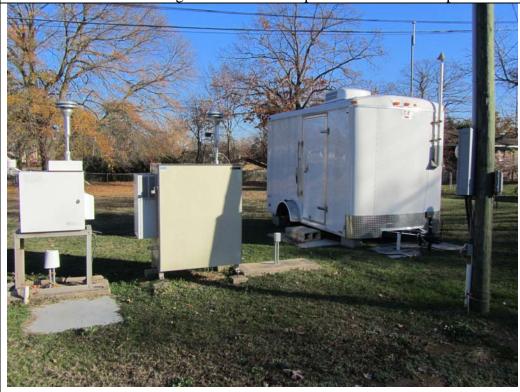
**Photo of:** the site including the trailer and the particulate matter samplers

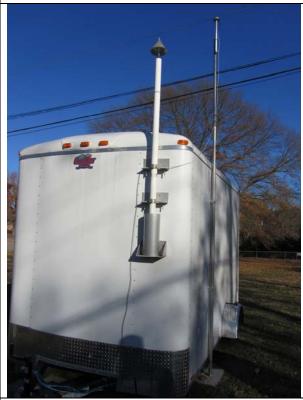
Photo of: manifold inlet on the trailer

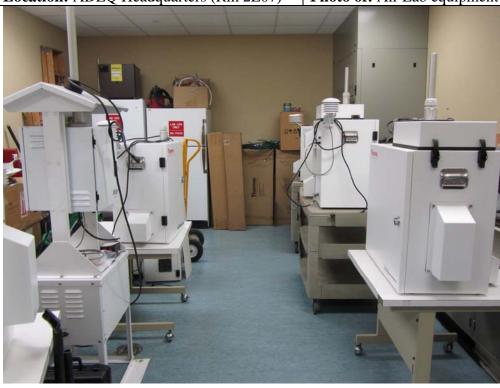
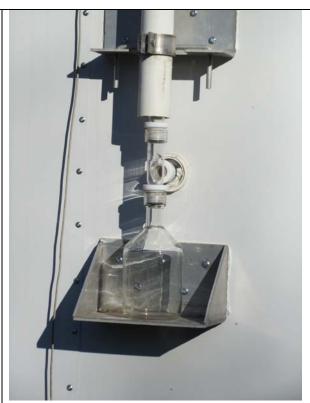
**Location:** ADEQ Headquarters (Rm 2L07) **Photo of:** Air Lab equipment storage and refrigeration

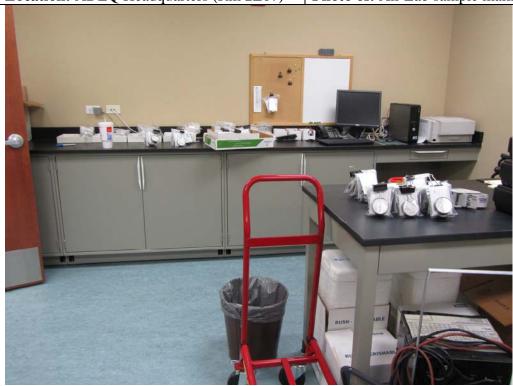
Photo of: Air Lab sample mailing area

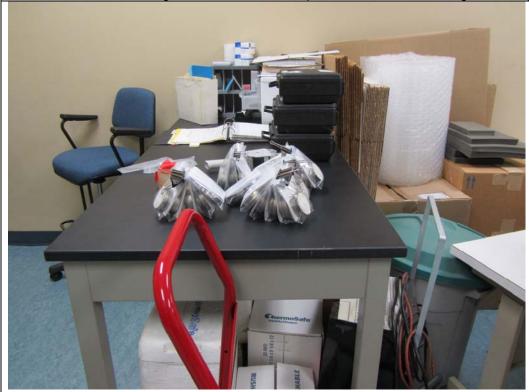
**Location:** ADEQ Headquarters (Rm 2L07) Photo of: Air Lab sample mailing area

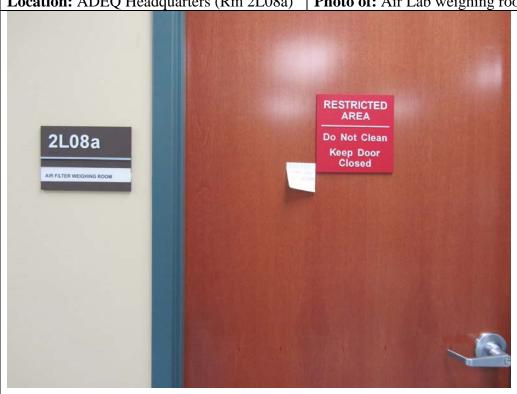
Location: ADEQ Headquarters (Rm 2L08a) Photo of: Air Lab weighing room

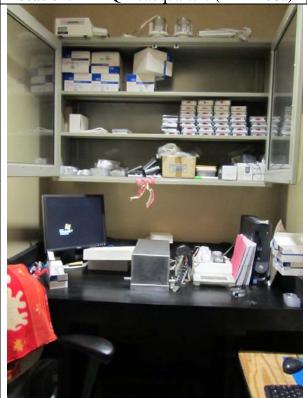
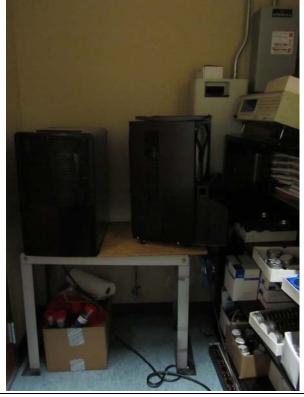
**Location:** ADEQ Headquarters (Rm 2L08a) **Photo of:** inside Air Lab weighing room

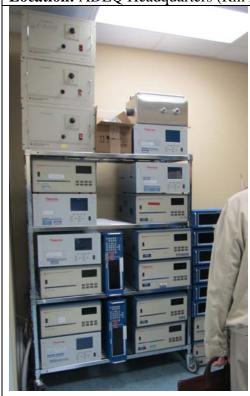
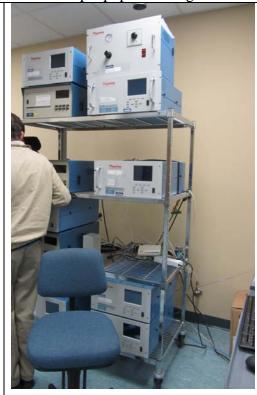
Location: ADEQ Headquarters (Rm 2L10) Photo of: backup equipment for gaseous instruments

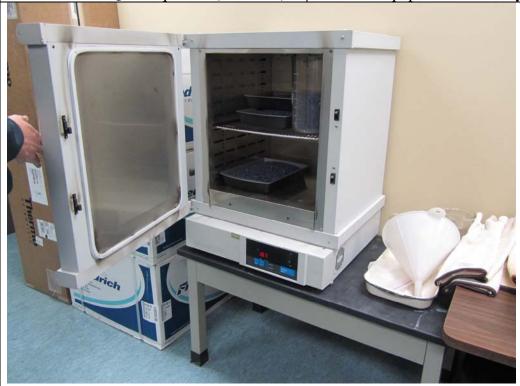
**Location:** ADEQ Headquarters (Rm 2L10) **Photo of:** equipment used to dry out impinger material
